ENVIRONMENTAL SITE ASSESSMENT

BECTON DICKINSON DIAGNOSTICS, INC.
CAYEY, P.R.

PP&A PROJECT #91010
APRIL, 1991

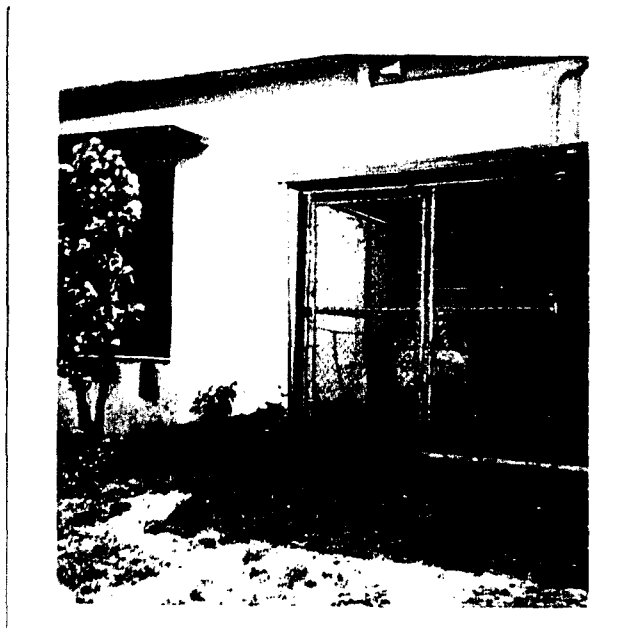
FIGURE 4
BRANSON MACHINE

BRANSON MACHINE

THIS MACHINE WAS USED TO RECOVER SOLVENTS (FREON).
IT IS LOCATED AT THE OUTSIDE OF THE BUILDING.

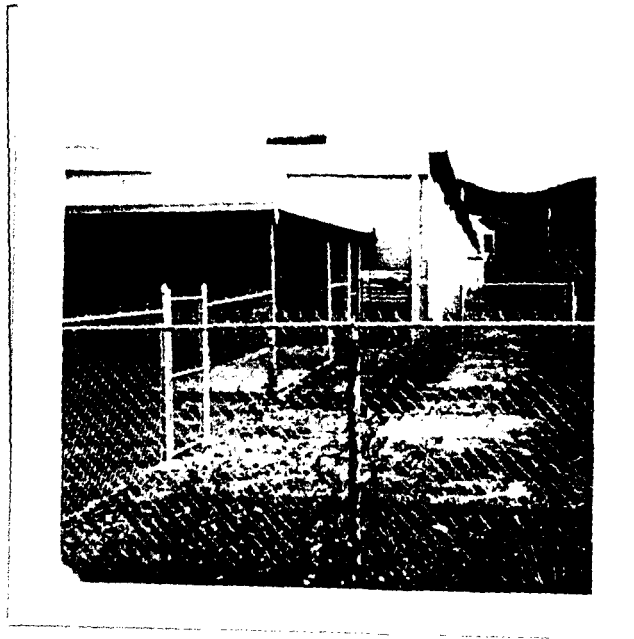
UNDERGROUND TANK

There is an underground diesel tank in the facilities. The tank was used to storage diesel for their emergency generator. The tank is not listed in the Environmental Quality Board (EQB) and does not have corrosion protection. The product in the tank was sampled and quantity was estimated in 5,658 gals. There are two phases, the lower is basically water and was estimated in 1,655 gals, the upper phases (hydrocarbons) were estimated in 4,003 gals.

THIS IS UNDERGRUOND DIESEL TANK. IT IS LOCATED IN THE BACKYARD.
THE AREA IS COVERED WITH CEMENT AND HAS A FENCE AROUND IT.
IT WAS USED FOR THE EMERGENCY GENERATOR.

- 5.2.2 Even when the samples of the injection wells and septic tank are negative to hazardous material, we recommend that these be closed to eliminate the potential of future misuse.
- 5.2.3 The underground diesel tank is not registered in the Environmental Quality Board. Also, there is an incident with the product that occurred on April 2, 1991. There is no drawing of the tank and, also, we do not know the exact capacity. These are too many unknown parameters so we strongly recommend to remove the tank completely from the ground in conformity with all regulatory requirements.
- 5.2.4 In respect to the asbestos in the top of the building (back area), the environmental law is changing and even though it does not represent a high problem at the moment, it should be encapsulated in place or removed. We recommend to remove it because in that way you eliminate the concern once and for all.
